RECREATION

All Gerflor experience for a highly performing recreational floor: environmental friendly, low VOC, no solvent, no heavy metal and 100% recyclable suitable for leisure and sports activities.

# RECREATION 45

# RECREATION 60

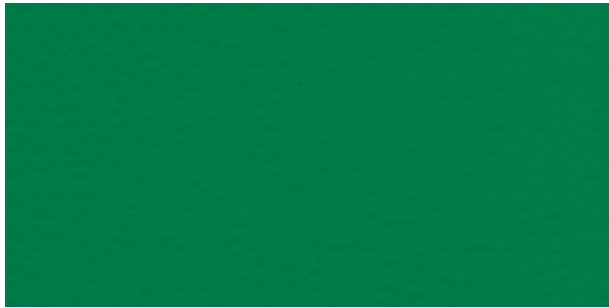
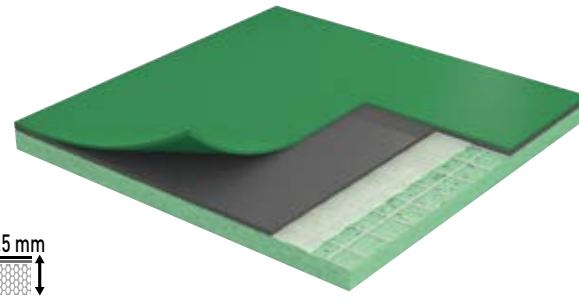
6563 Menta

4.5 mm

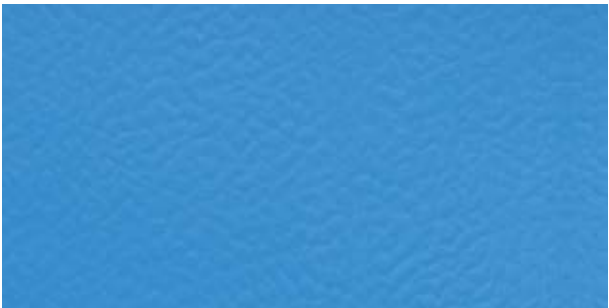
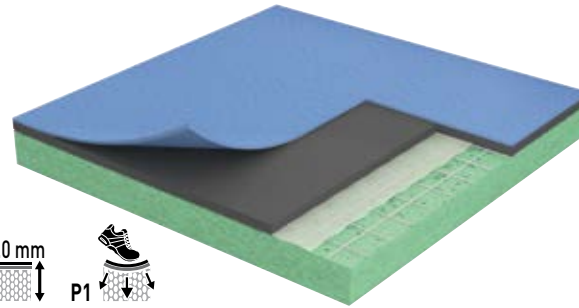
2402 Azul

6.0 mm
